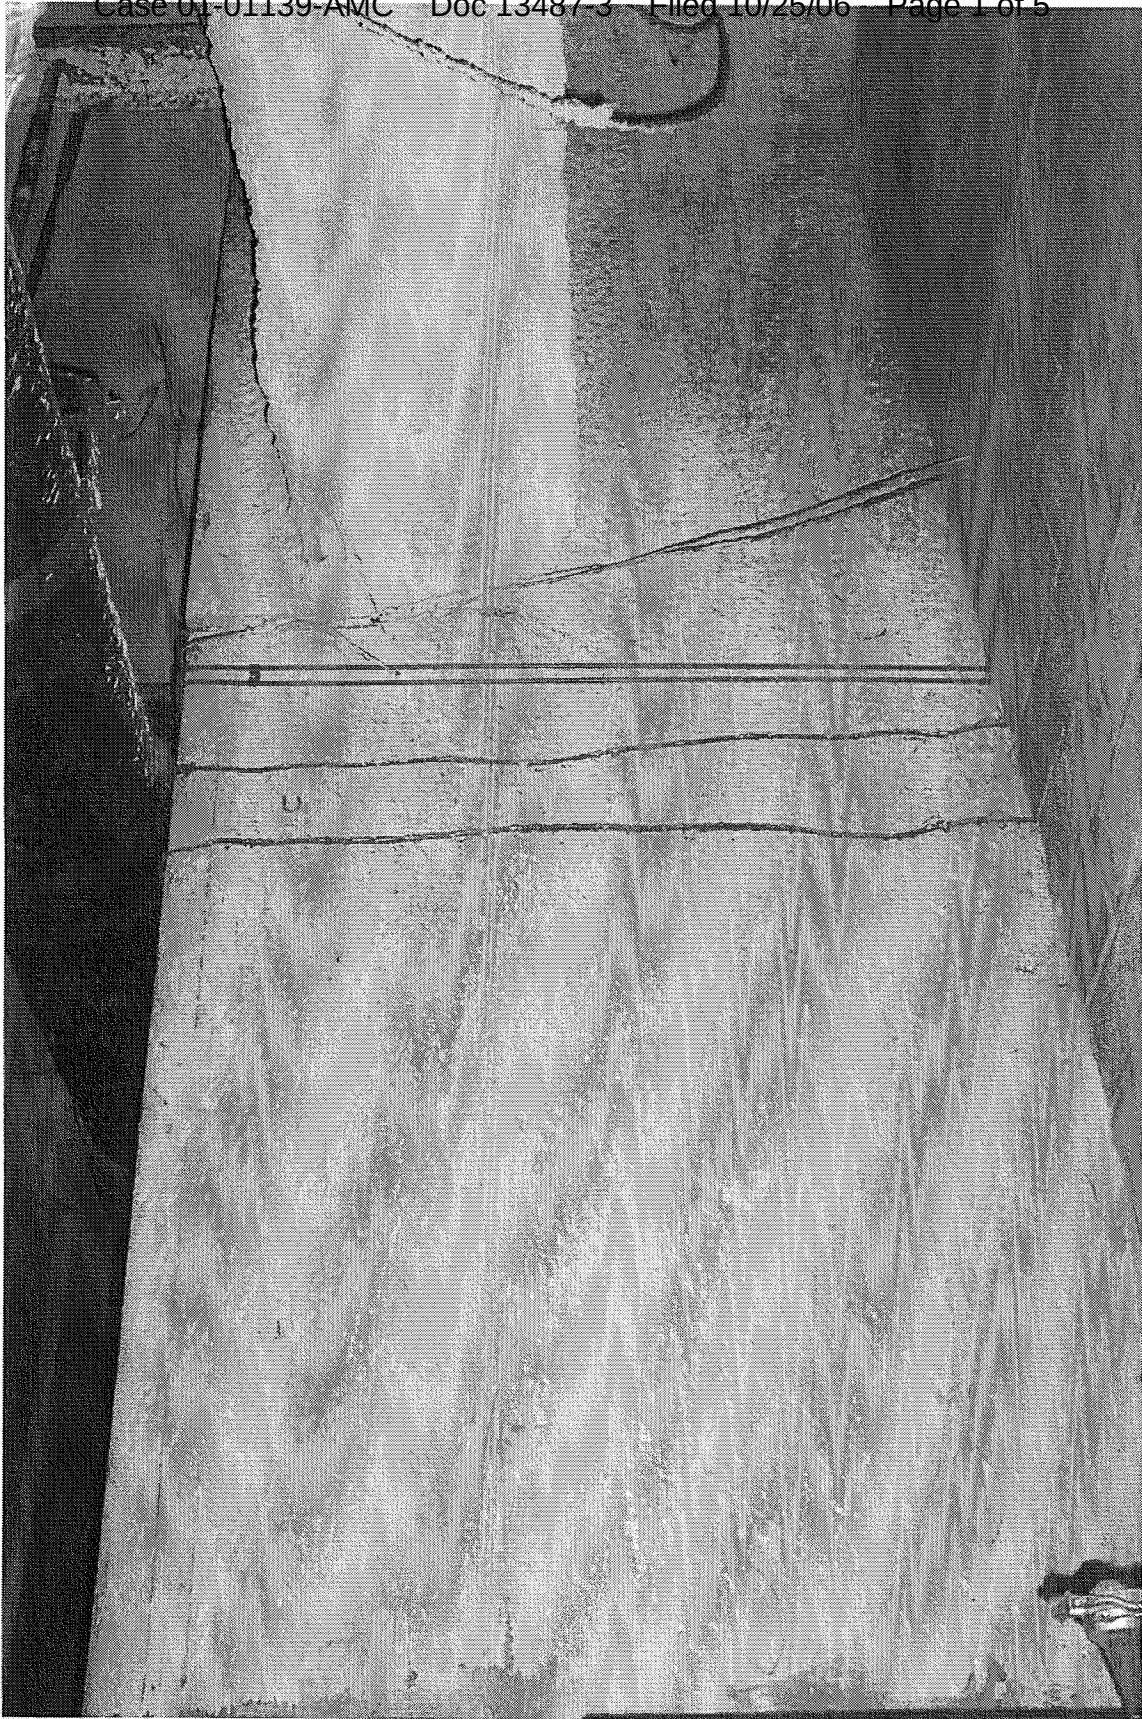
21. 1st floor, SW mechanical room - View of exposed fireproofed sprayed beam

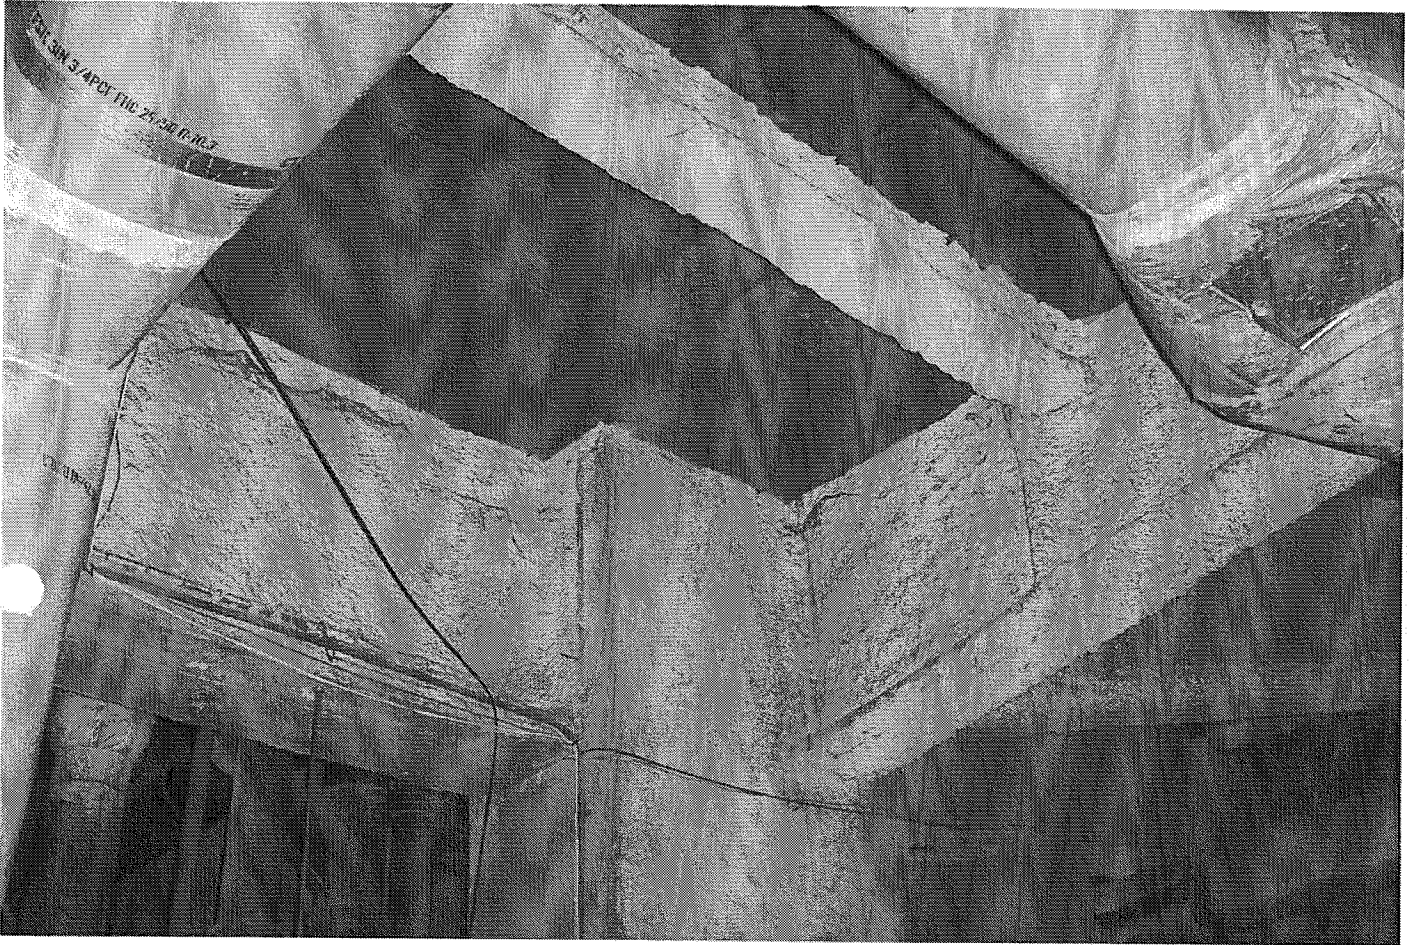
22. 1st floor, NW mechanical room - View of exposed fireproofed structural members

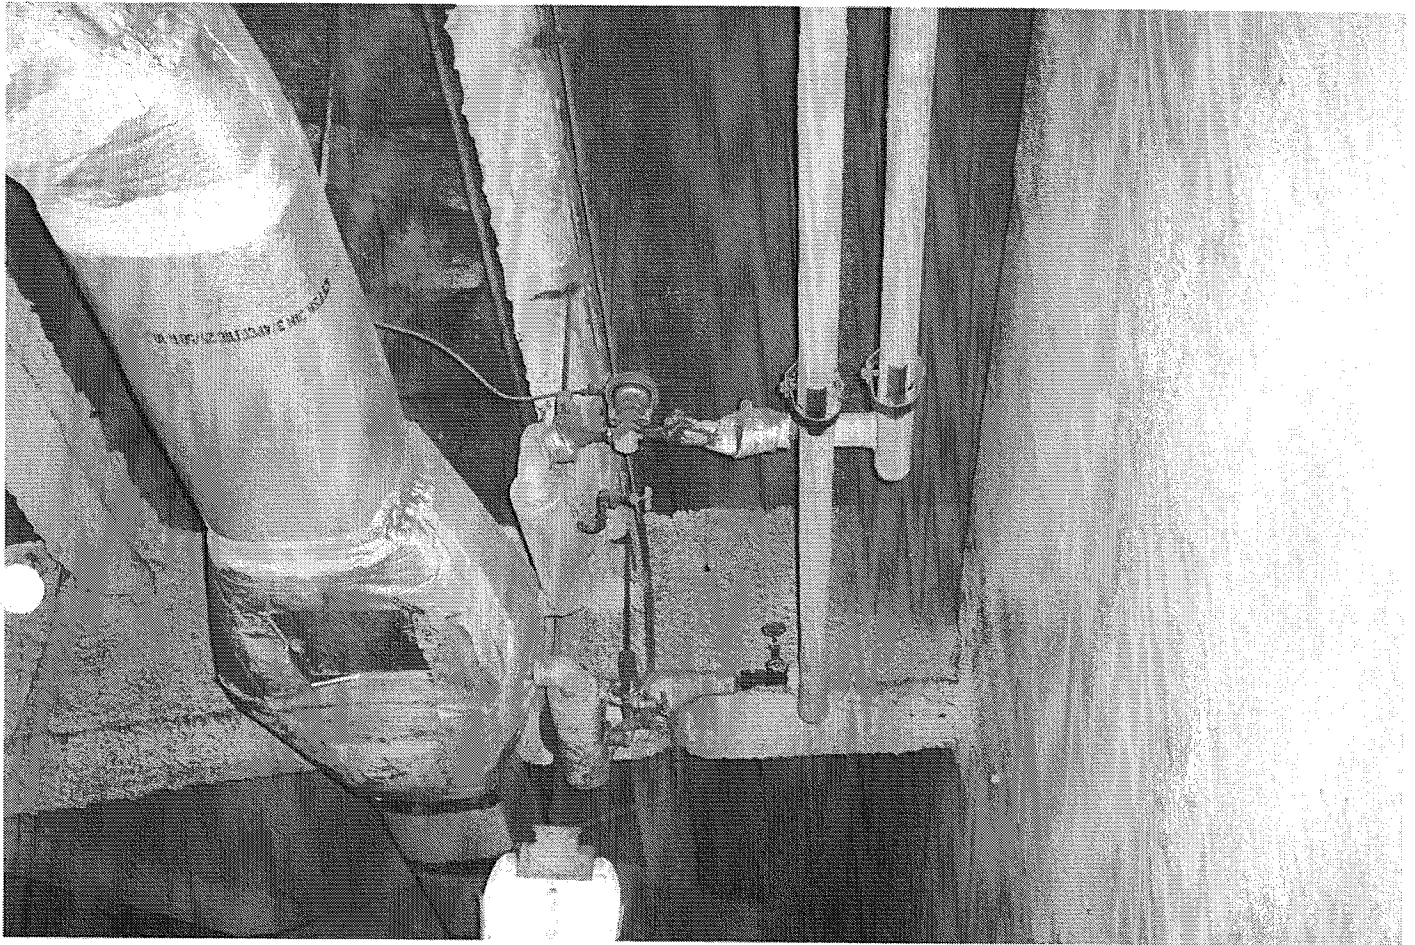
23. 1st floor, NW mechanical room - View of exposed fireproofed structural members

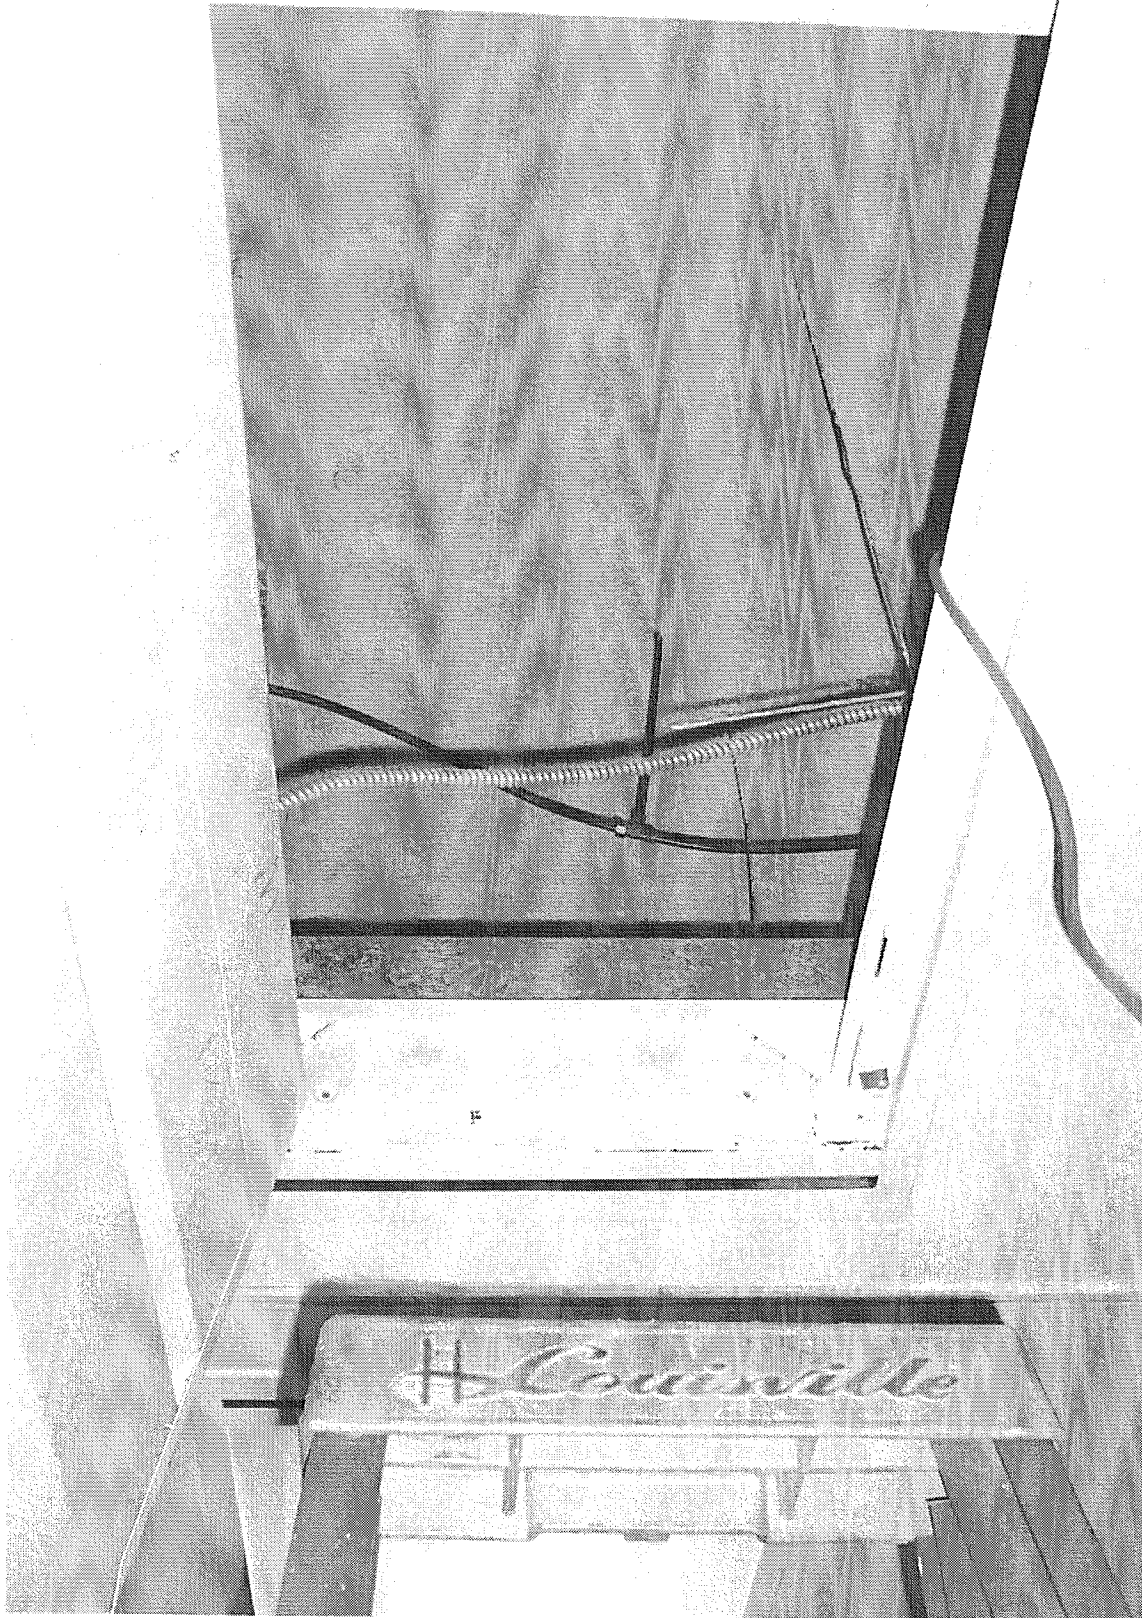
24. 24th floor, adjacent to room W2412B - View of fireproofed sprayed decking above suspended ceiling

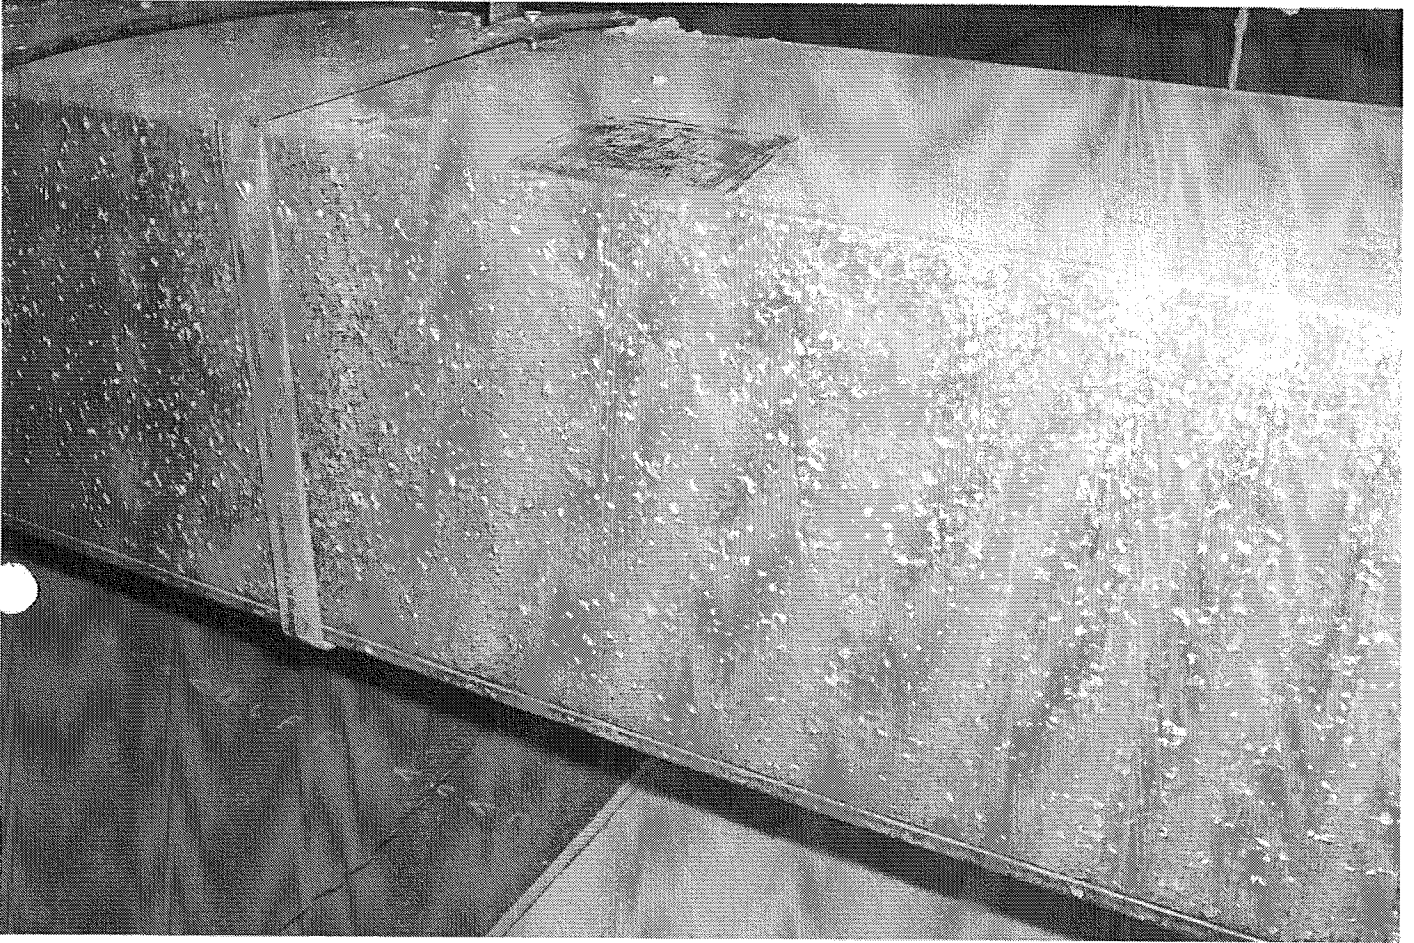
25. 24th floor, adjacent to room W2412B - Location of dust sample #1
